# ANNUAL RESTORATION MONITORING REPORT

## YEAR 6

SAN FELIPE CREEK RESTORATION PROJECT  
SANTA CLARA VALLEY HABITAT AGENCY

**FEBRUARY 10, 2025**

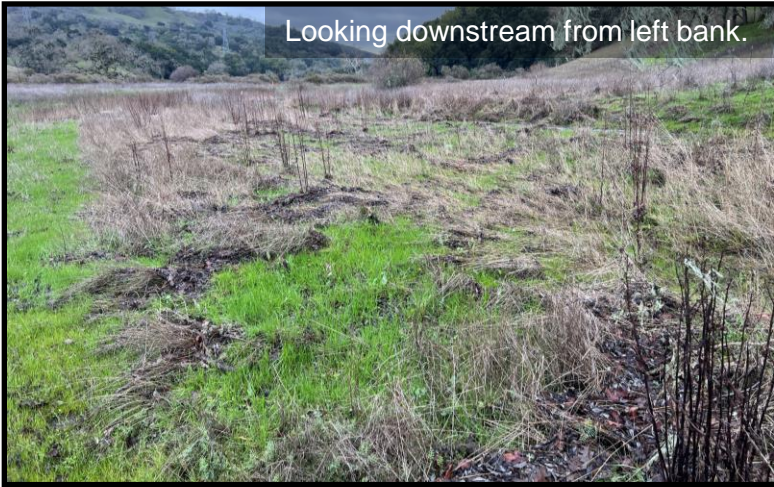
Looking downstream from left bank.

ID03-01: 2/19/2024 Evidence of floodplain inundation near upstream end of created floodplain feature.

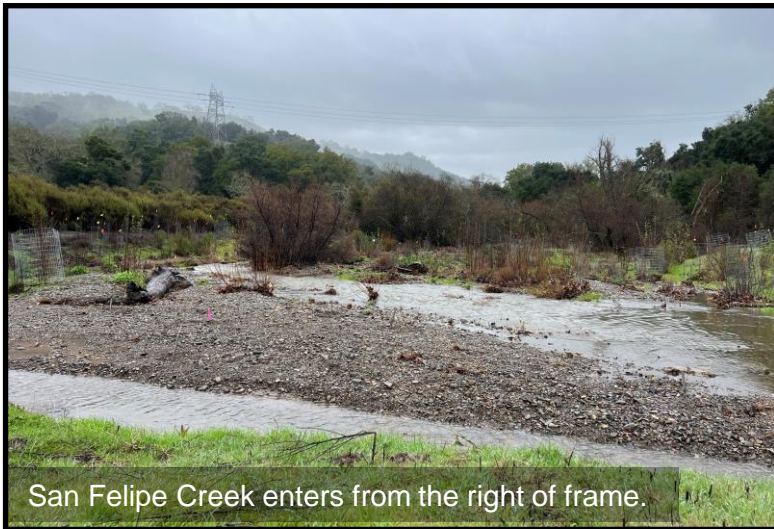
San Felipe Creek enters from the right of frame.

ID03-03/04: 2/19/2024. Flows partially inundating ID03-03 and ID03-04 (background).

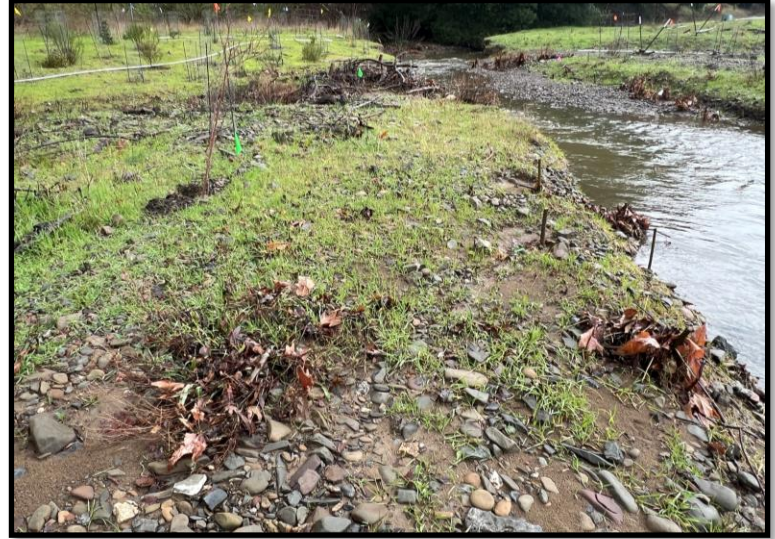
ID03-02: 2/19/2024. Partial floodplain inundation likely occurred based on wracked leaves on floodplain

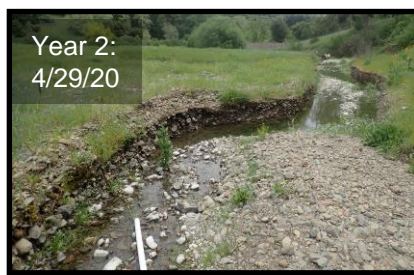
Year 3: 9/21/21  
Bio-engineered debris jam, ballast  
and slash placed in channel

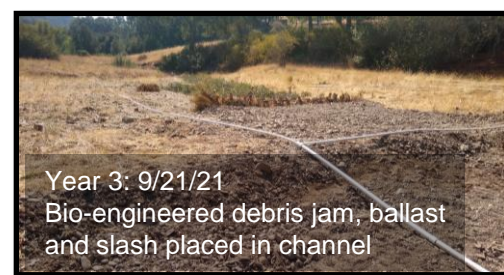
Year 4: 9/23/22 One year after installation of bio-engineered debris jam, ballast and slash.

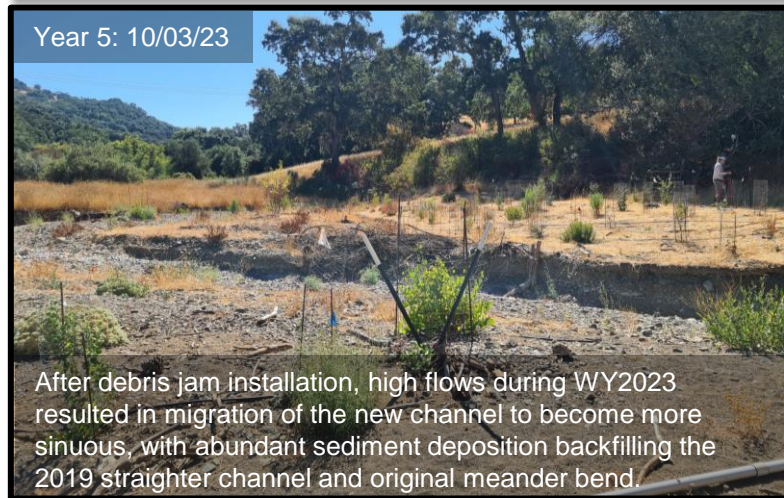
After debris jam installation, high flows during WY2023 resulted in migration of the new channel to become more sinuous, with abundant sediment deposition backfilling the 2019 straighter channel and original meander bend.

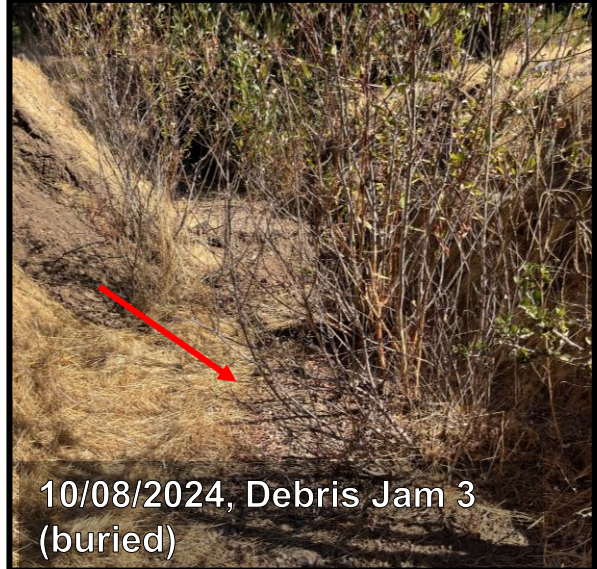
10/08/2024, Debris Jam 3  
(buried)

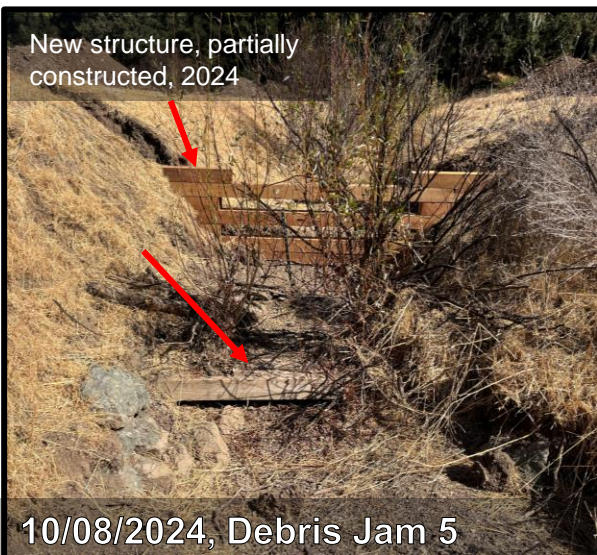
10/08/2024, Debris Jam 4

**Figure 19. Staked debris jams at ID02-01, October 8, 2024, San Felipe Creek Restoration Project, Joseph D. Grant Park, Santa Clara County, California.** All photos are taken looking upstream except Debris Jam 6. Photos were taken during construction to install another round of timber debris jams, which can be seen in progress behind Debris Jam 5.

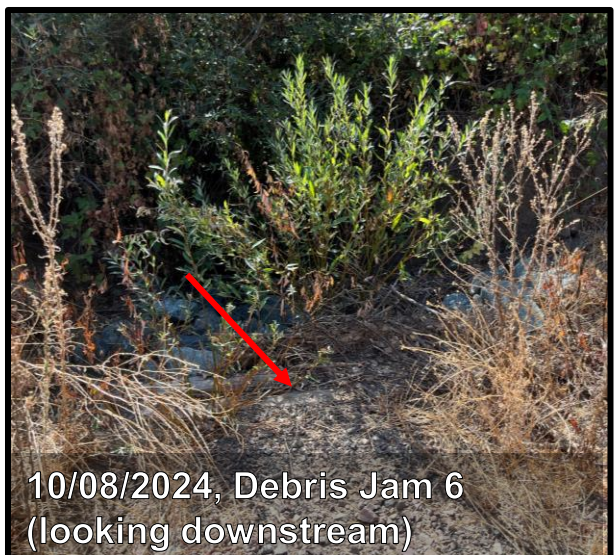
10/08/2024, Debris Jam 5

Erosion occurred at the downstream-most timber staked debris jam (Debris Jam 6, **Figure 19**) during WY2023. Debris wracked on an improperly installed fence (which was installed along the top of Debris Jam 6) caused streamflow to erode the banks adjacent to the staked debris jam on both the right and left sides and created scour holes adjacent and just downstream of the staked debris jam. The recommended repair was completed by SCVHA and Triangle Properties in coordination with the Balance project design and monitoring team on November 6, 2023. This work consisted of the removal of the fence installed across the tributary (on top of Staked Debris Jam 6), and stabilization of the erosional area that was caused by the placement of the fence. The area was stabilized by layering of large rock, slash, and compacted soil, as well as planting willow stakes and adding a debris jam along the right bank to prevent future erosion (**Figures 20, 21, and 22**). The bank remained stable during WY2024, with no further considerable bank erosion observed in this area.

During WY2024, following winter high flows we observed that all of the staked debris jams were functioning as intended, serving to capture episodic sediment delivered during high flows (**Figure 19**).

10/08/2024, Debris Jam 6  
(looking downstream)

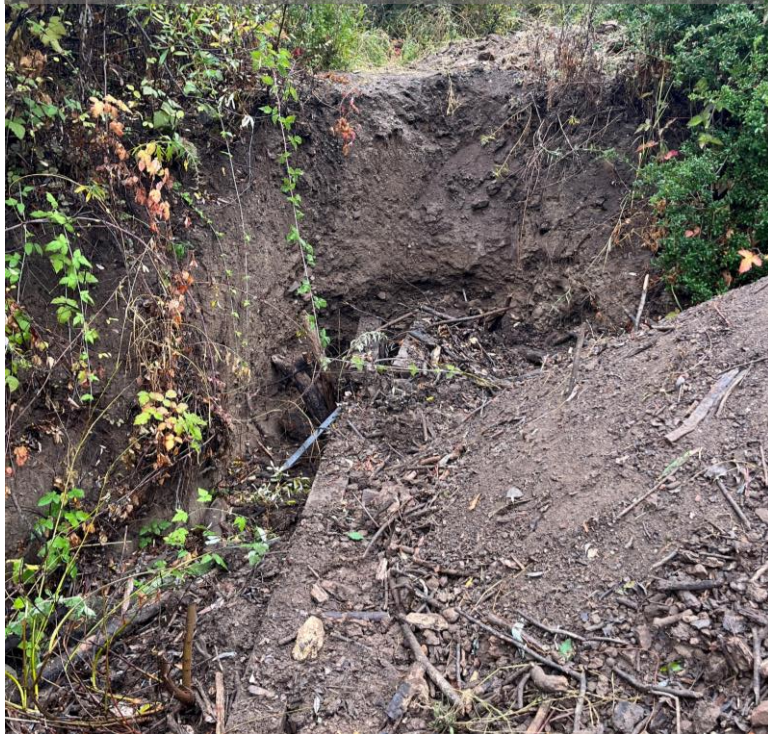
1. Before work began: after fence removal and site prep

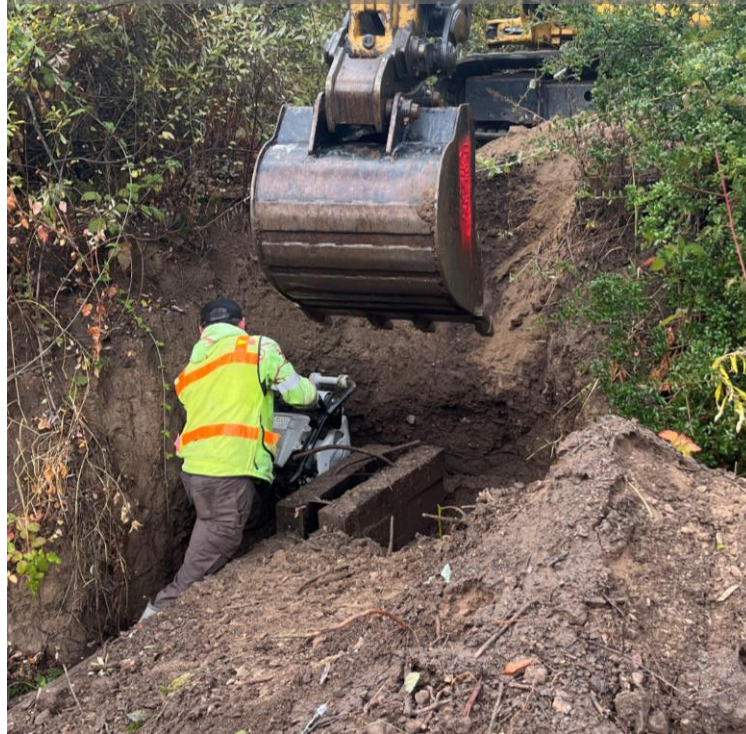
2. Compacted soil around RB end of staked debris jam timbers

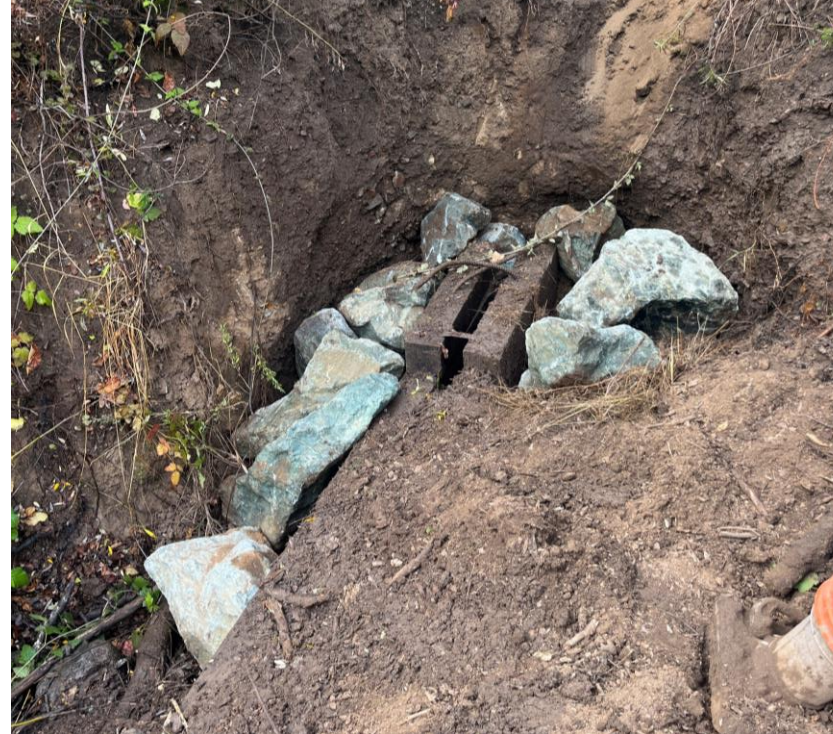
3. Added rock around timbers

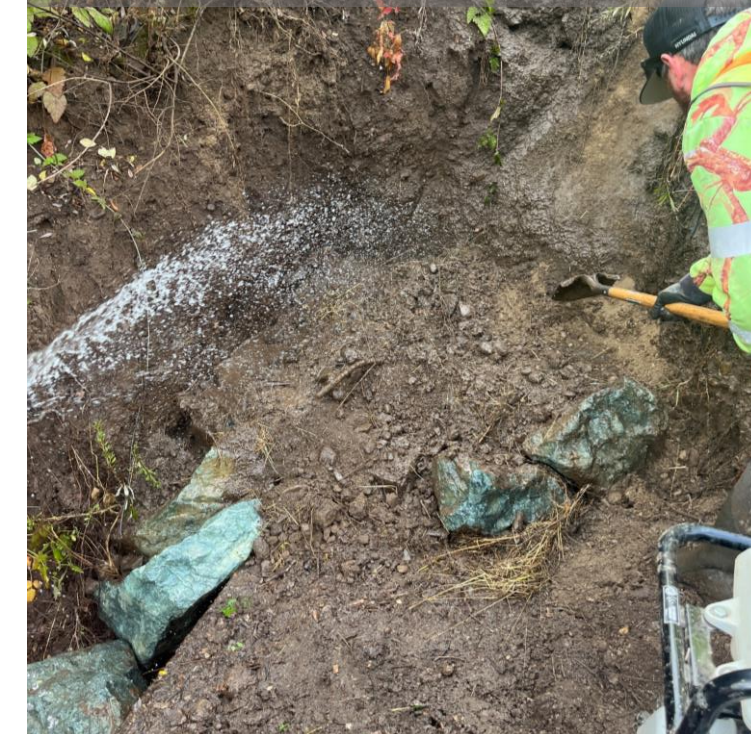
4. Added soil and water on top and in-between rock

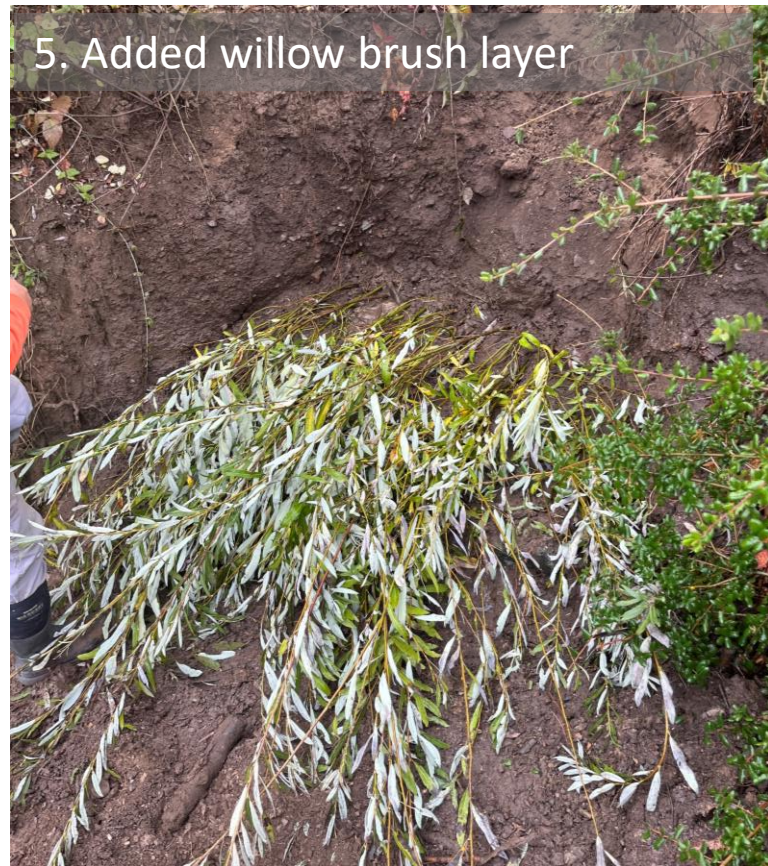
5. Added willow brush layer

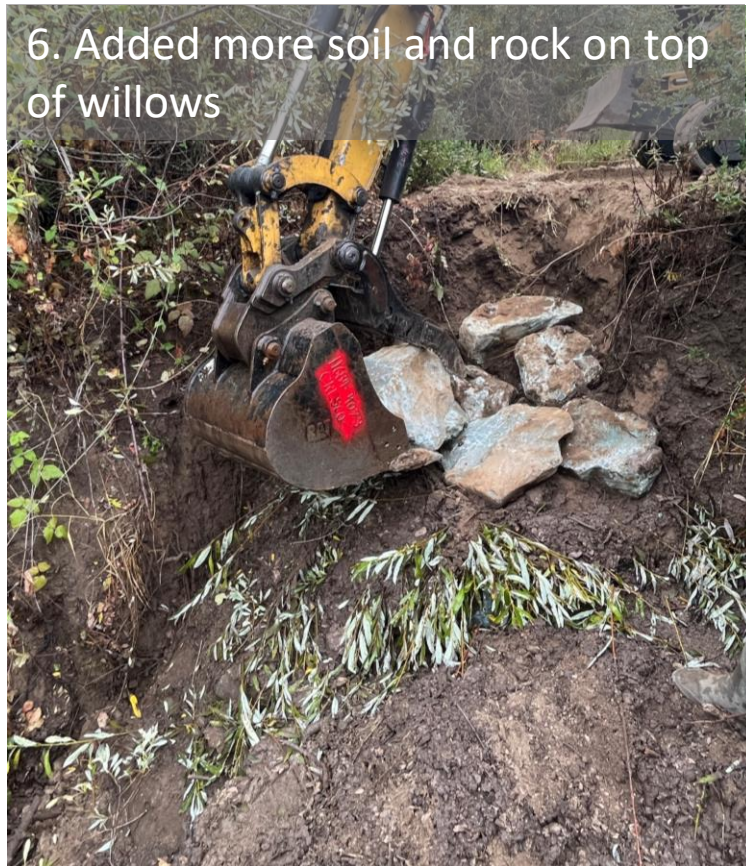
6. Added more soil and rock on top of willows

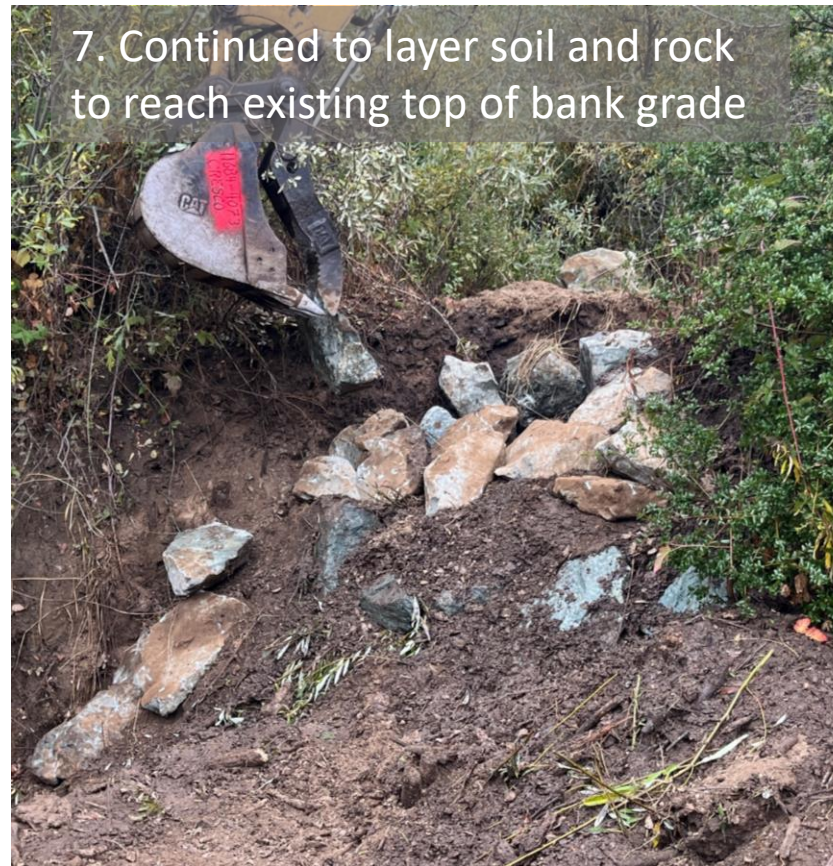
7. Continued to layer soil and rock to reach existing top of bank grade

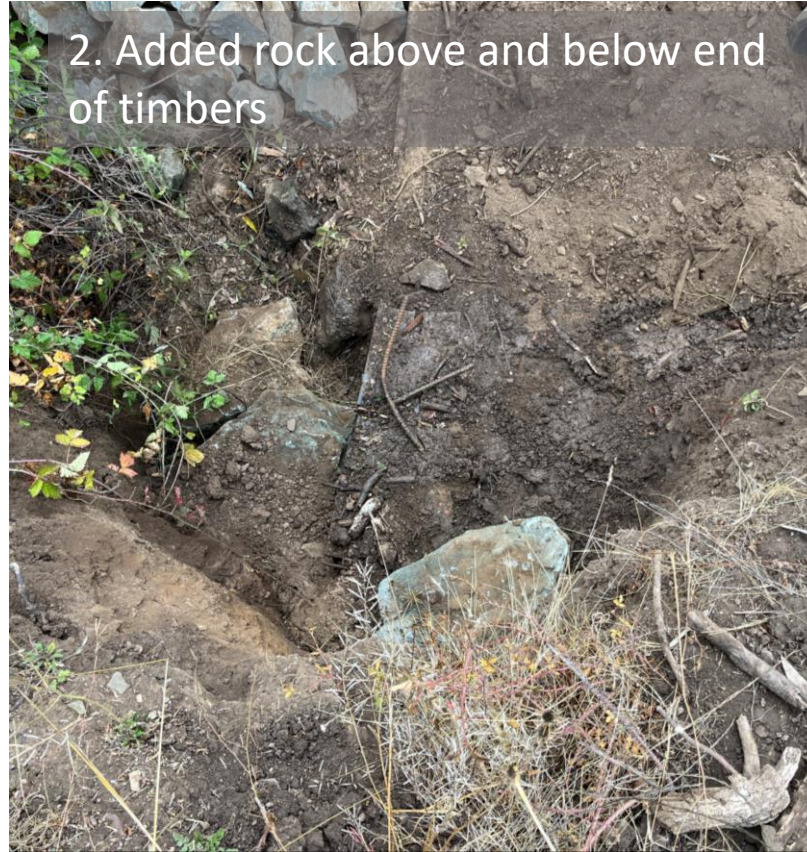
2. Added rock above and below end of timbers

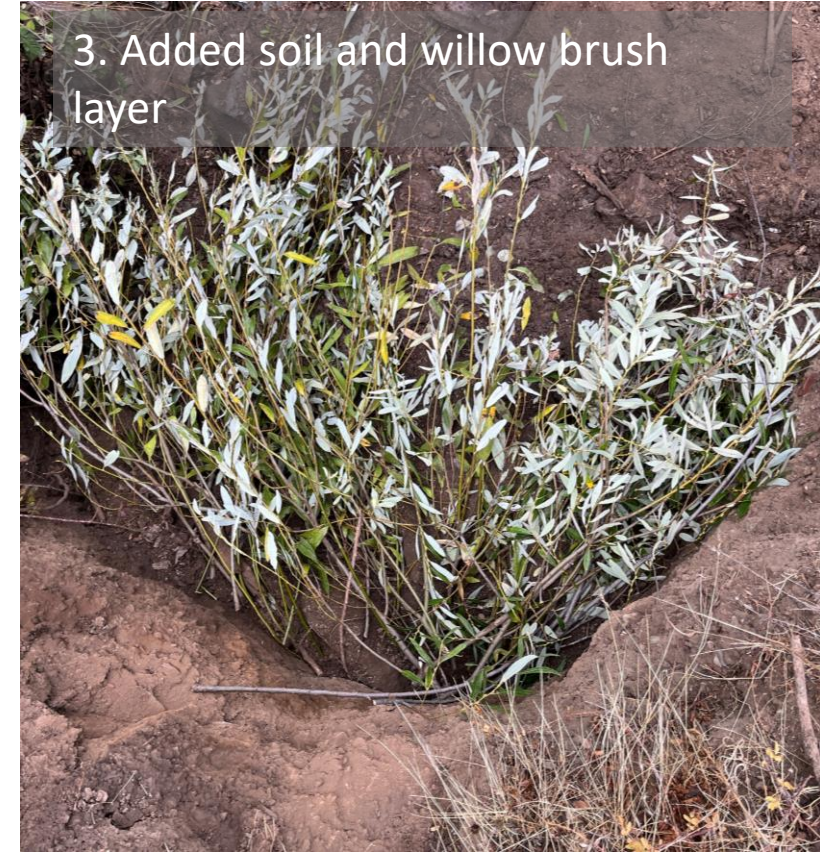
3. Added soil and willow brush layer

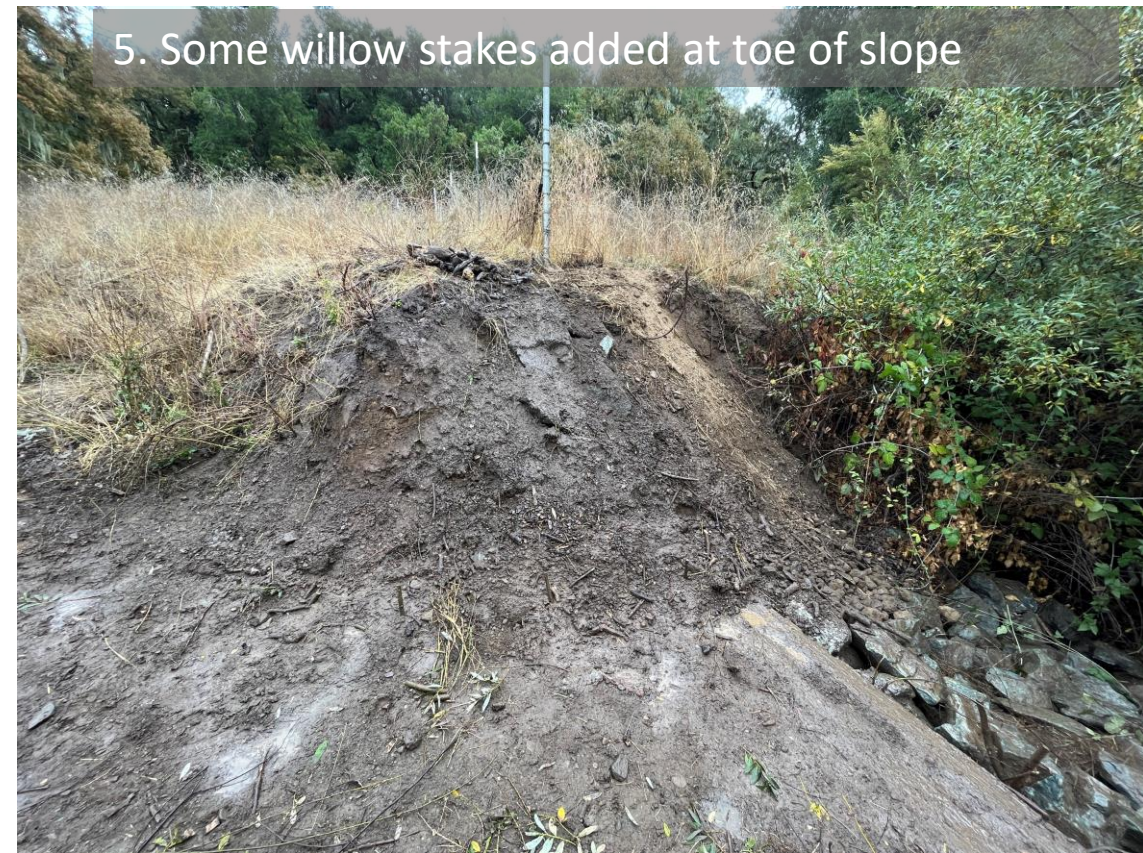
5. Some willow stakes added at toe of slope

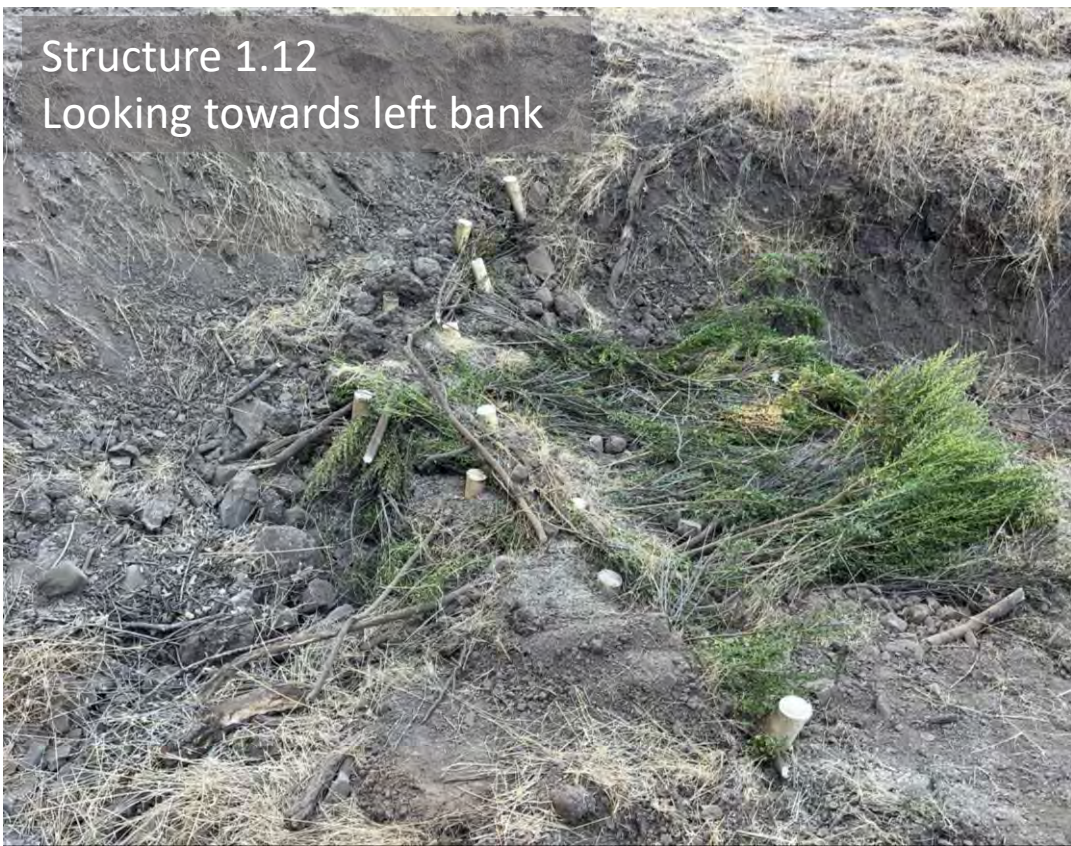
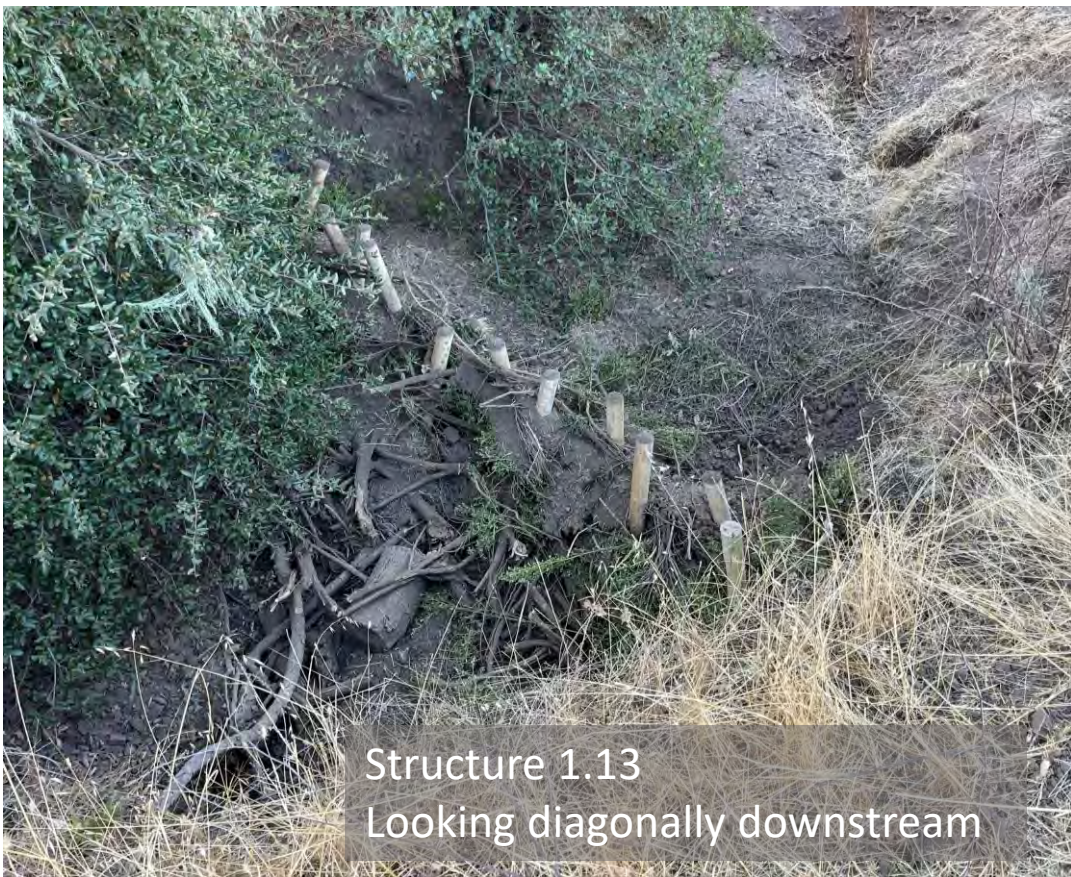
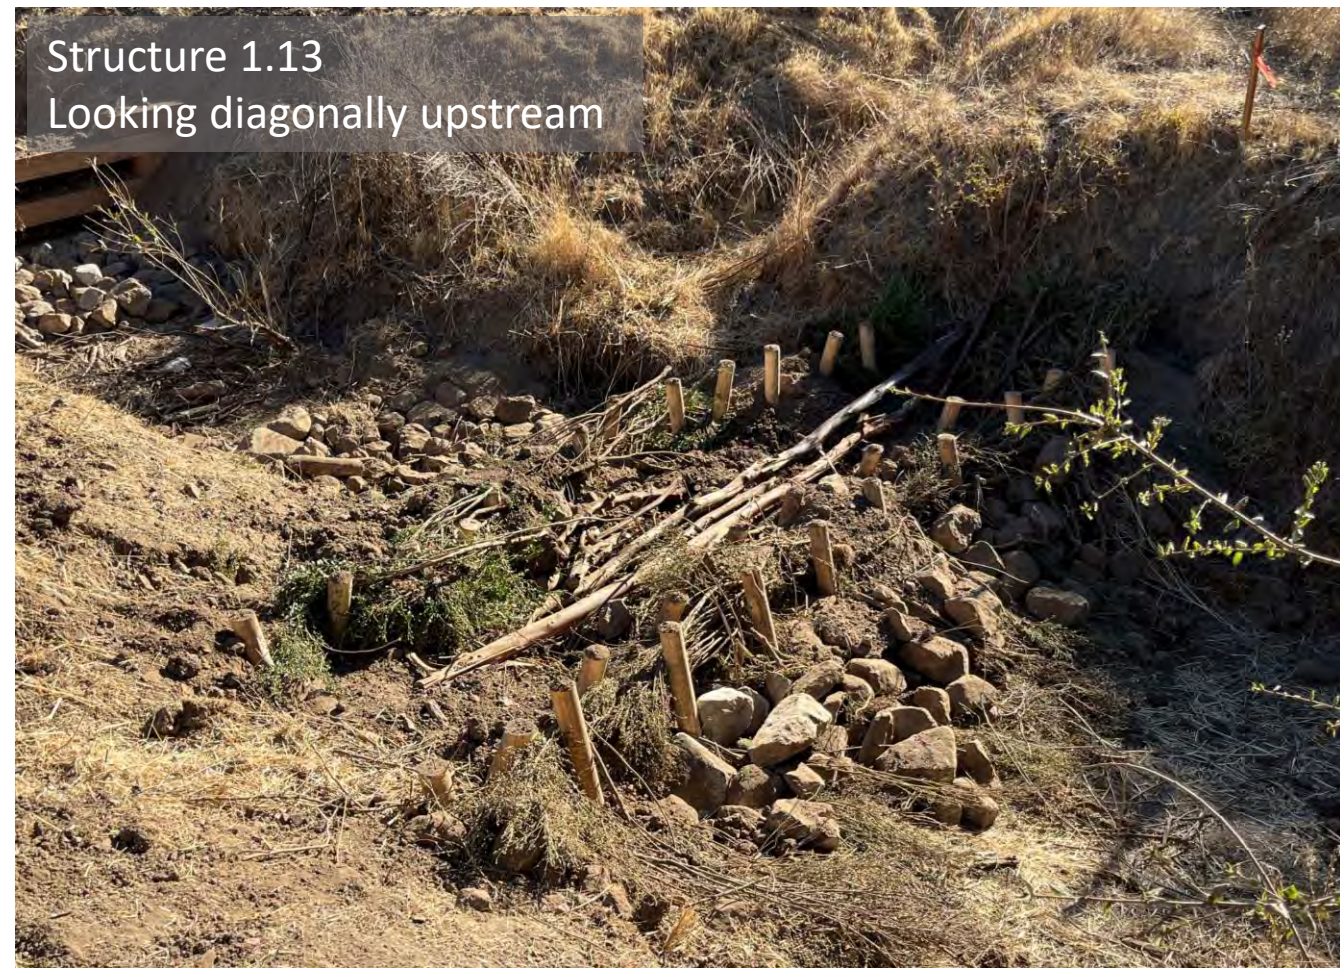
**Figure 4. Incised Eastern Tributary Type 1 Debris Jams, As-built photos, October 2024, San Felipe Restoration Project 2024 Adaptive Management, Santa Clara County, California.**

Helix installed three Type 2 timber debris jams, three Type 1 staked debris jams, and added rock to the existing terminal jam, as recommended. Design specifications as detailed in **Sheet 2** were followed closely. Some minor changes were made to the specifications based on field conditions. Photos of the completed work can be found in **Figure 4** and **Figure 5**. Deviations to the design specifications were as follows:

- c) For Jam 1.13, only one course of stakes was installed, in order to avoid negatively affecting the roots of the large oak tree on the left bank.
- d) On the middle Type 2 debris jam, a rough sawn redwood 2x6 support was split during construction. Another board was installed on the downstream side of the structure for extra support.
- e) Extra rock was placed upstream and downstream of structure 1.14 and downstream of structure 1.13.
- f) The soil that was added to structures 1.12, 1.13, and 1.14 was not jet or compacted with water due to equipment failure.

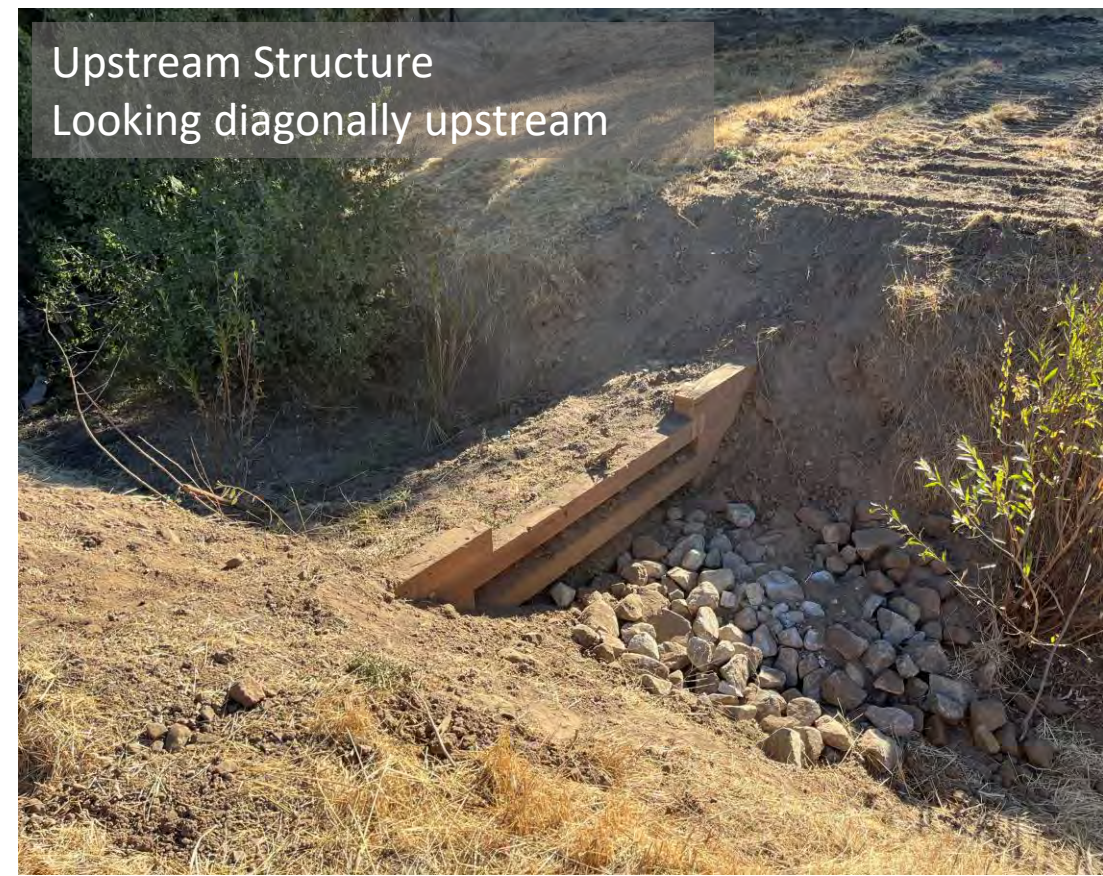
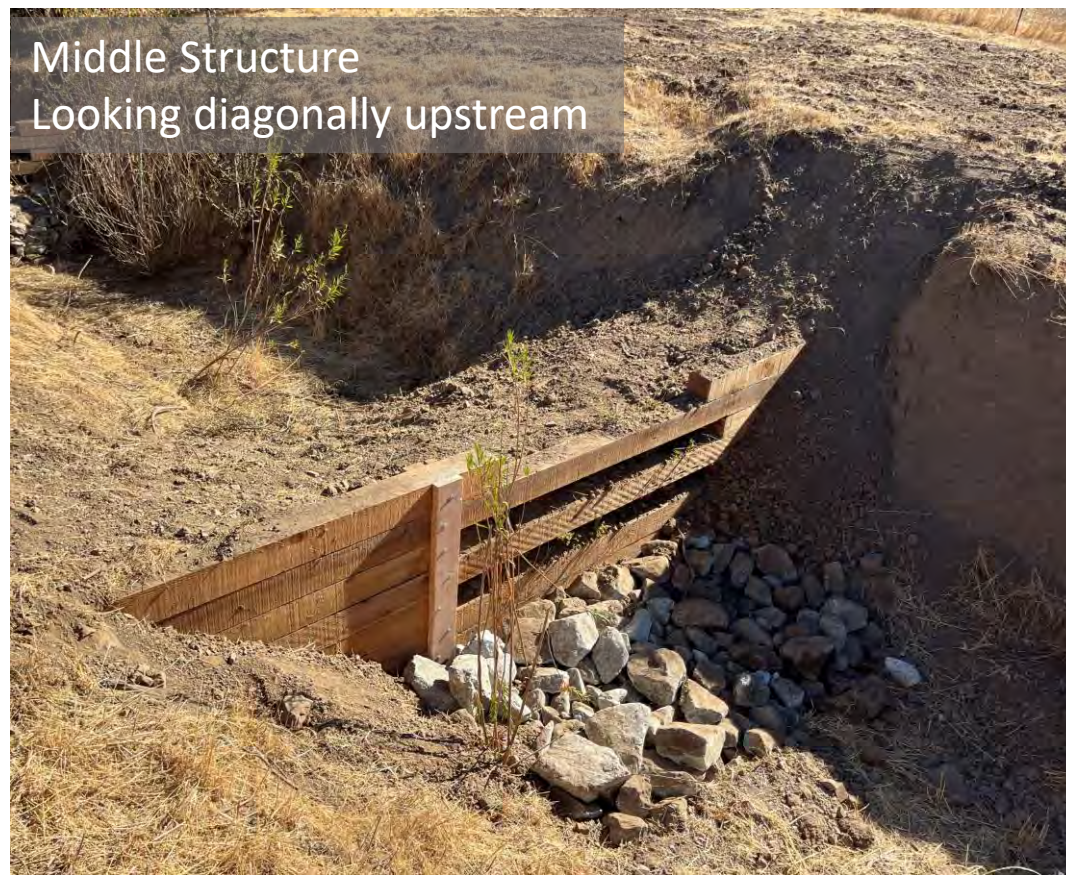
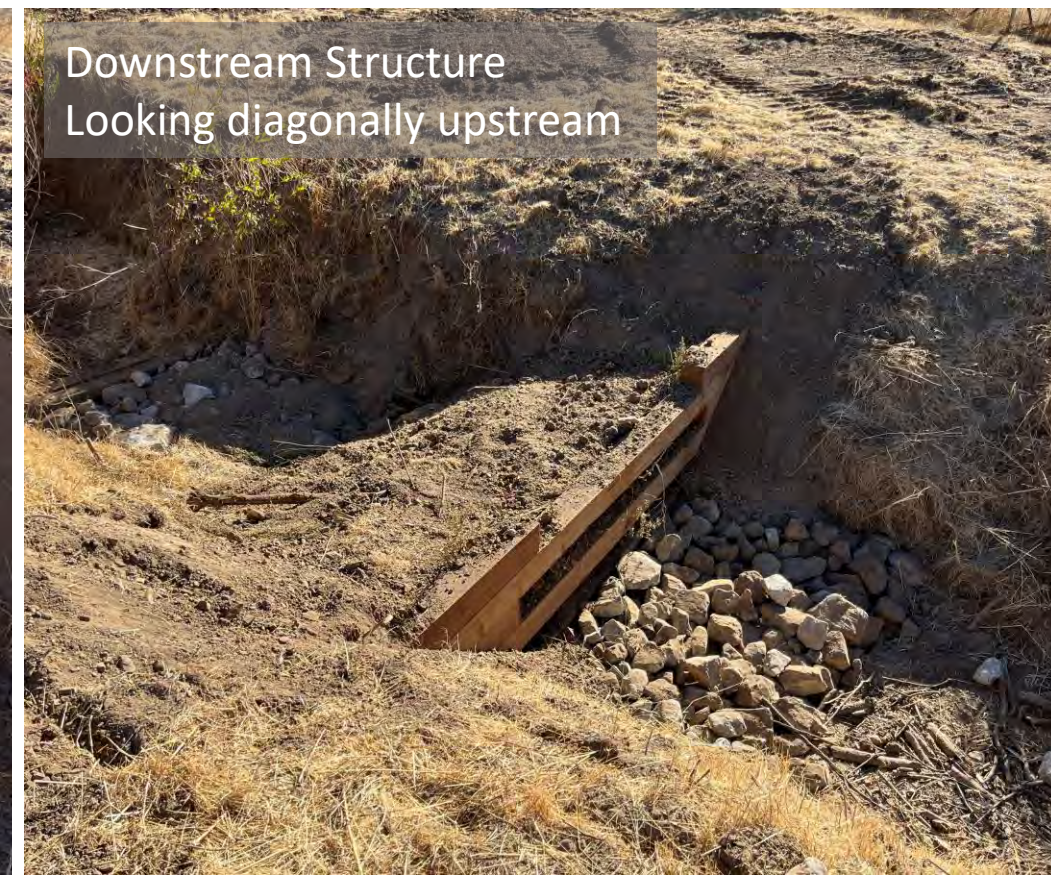
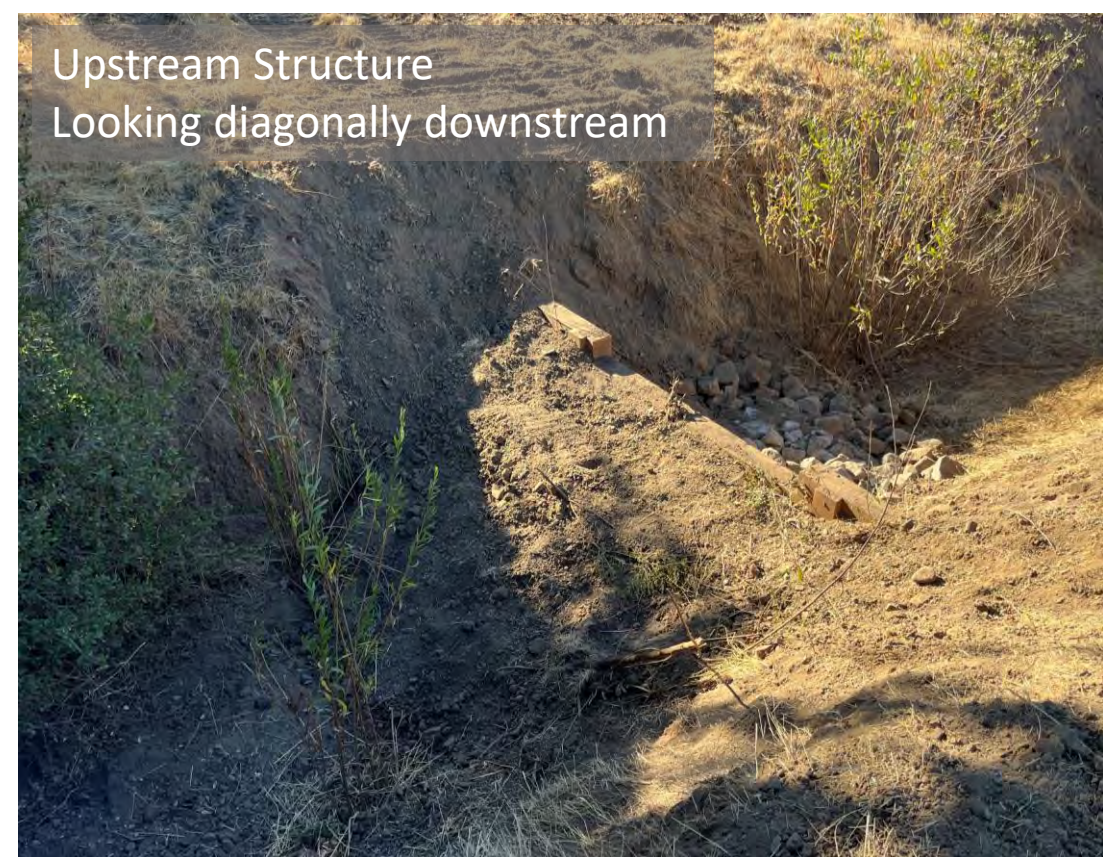
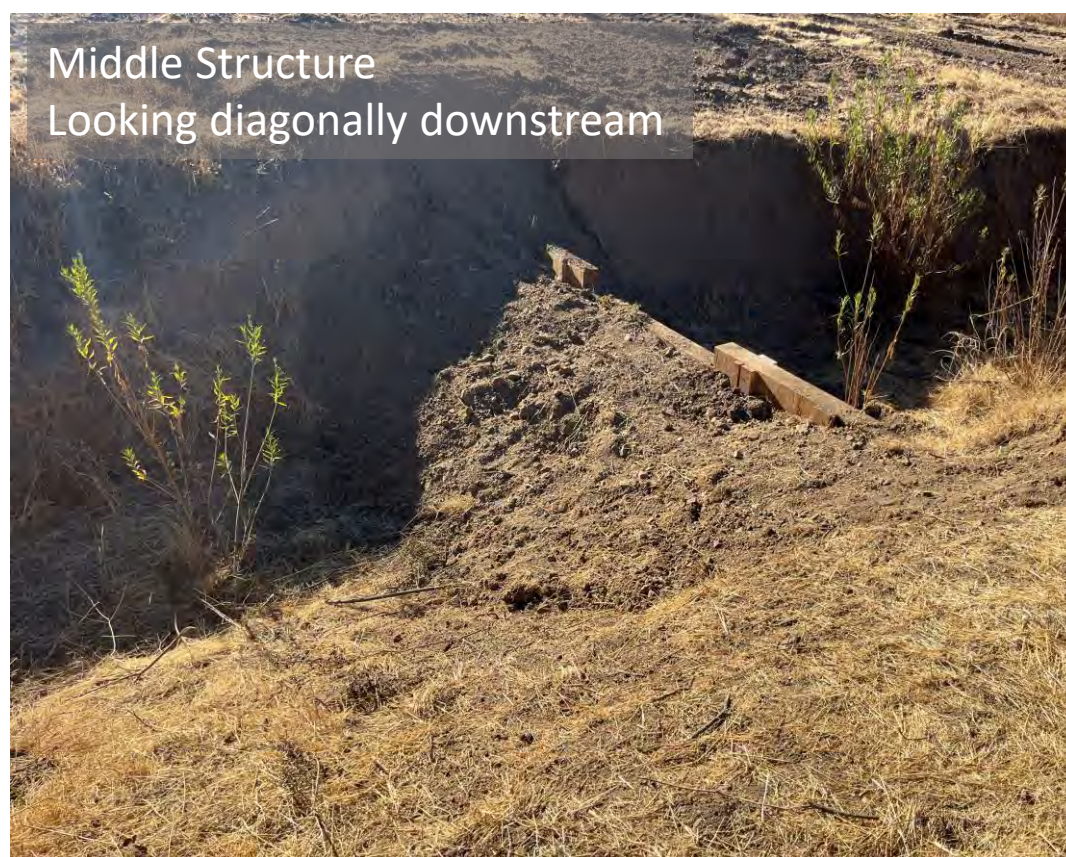
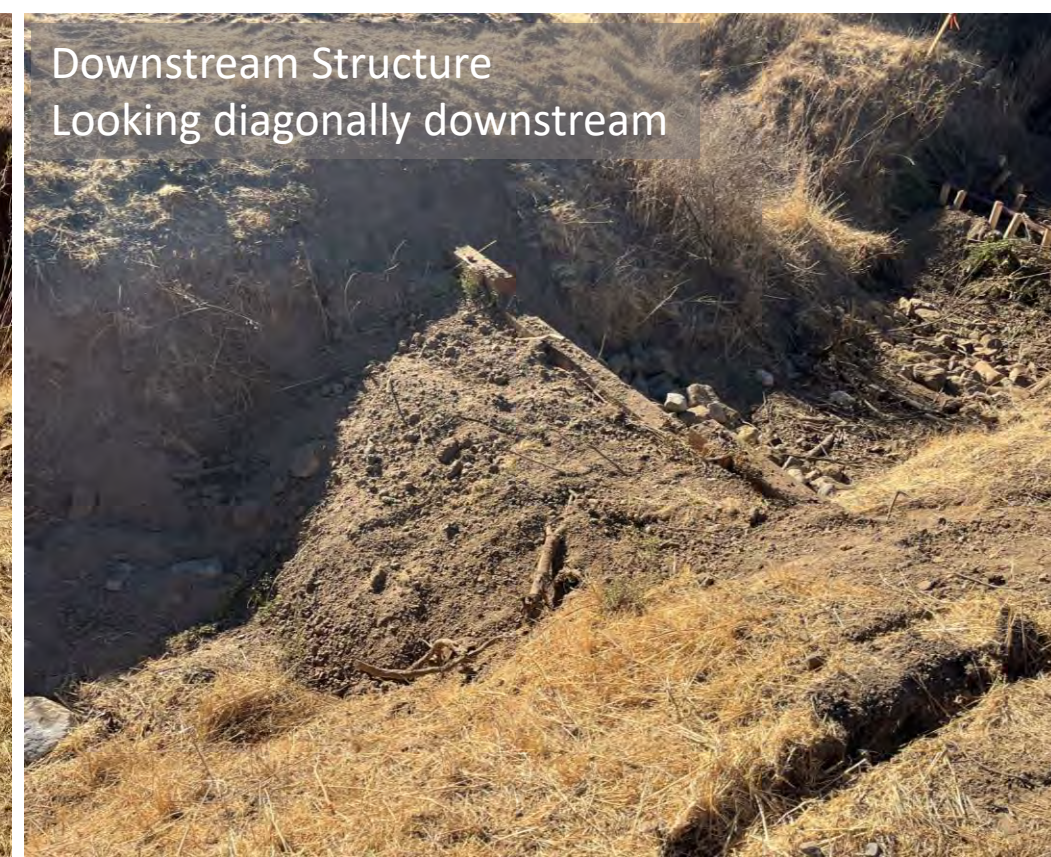
**Figure 5. Incised Eastern Tributary Type 2 Debris Jams, As-built photos, October 2024, San Felipe Restoration Project 2024 Adaptive Management, Santa Clara County, California.**
