# ANNUAL RESTORATION MONITORING REPORT

## YEAR 6

SAN FELIPE CREEK RESTORATION PROJECT  
SANTA CLARA VALLEY HABITAT AGENCY

**FEBRUARY 10, 2025**

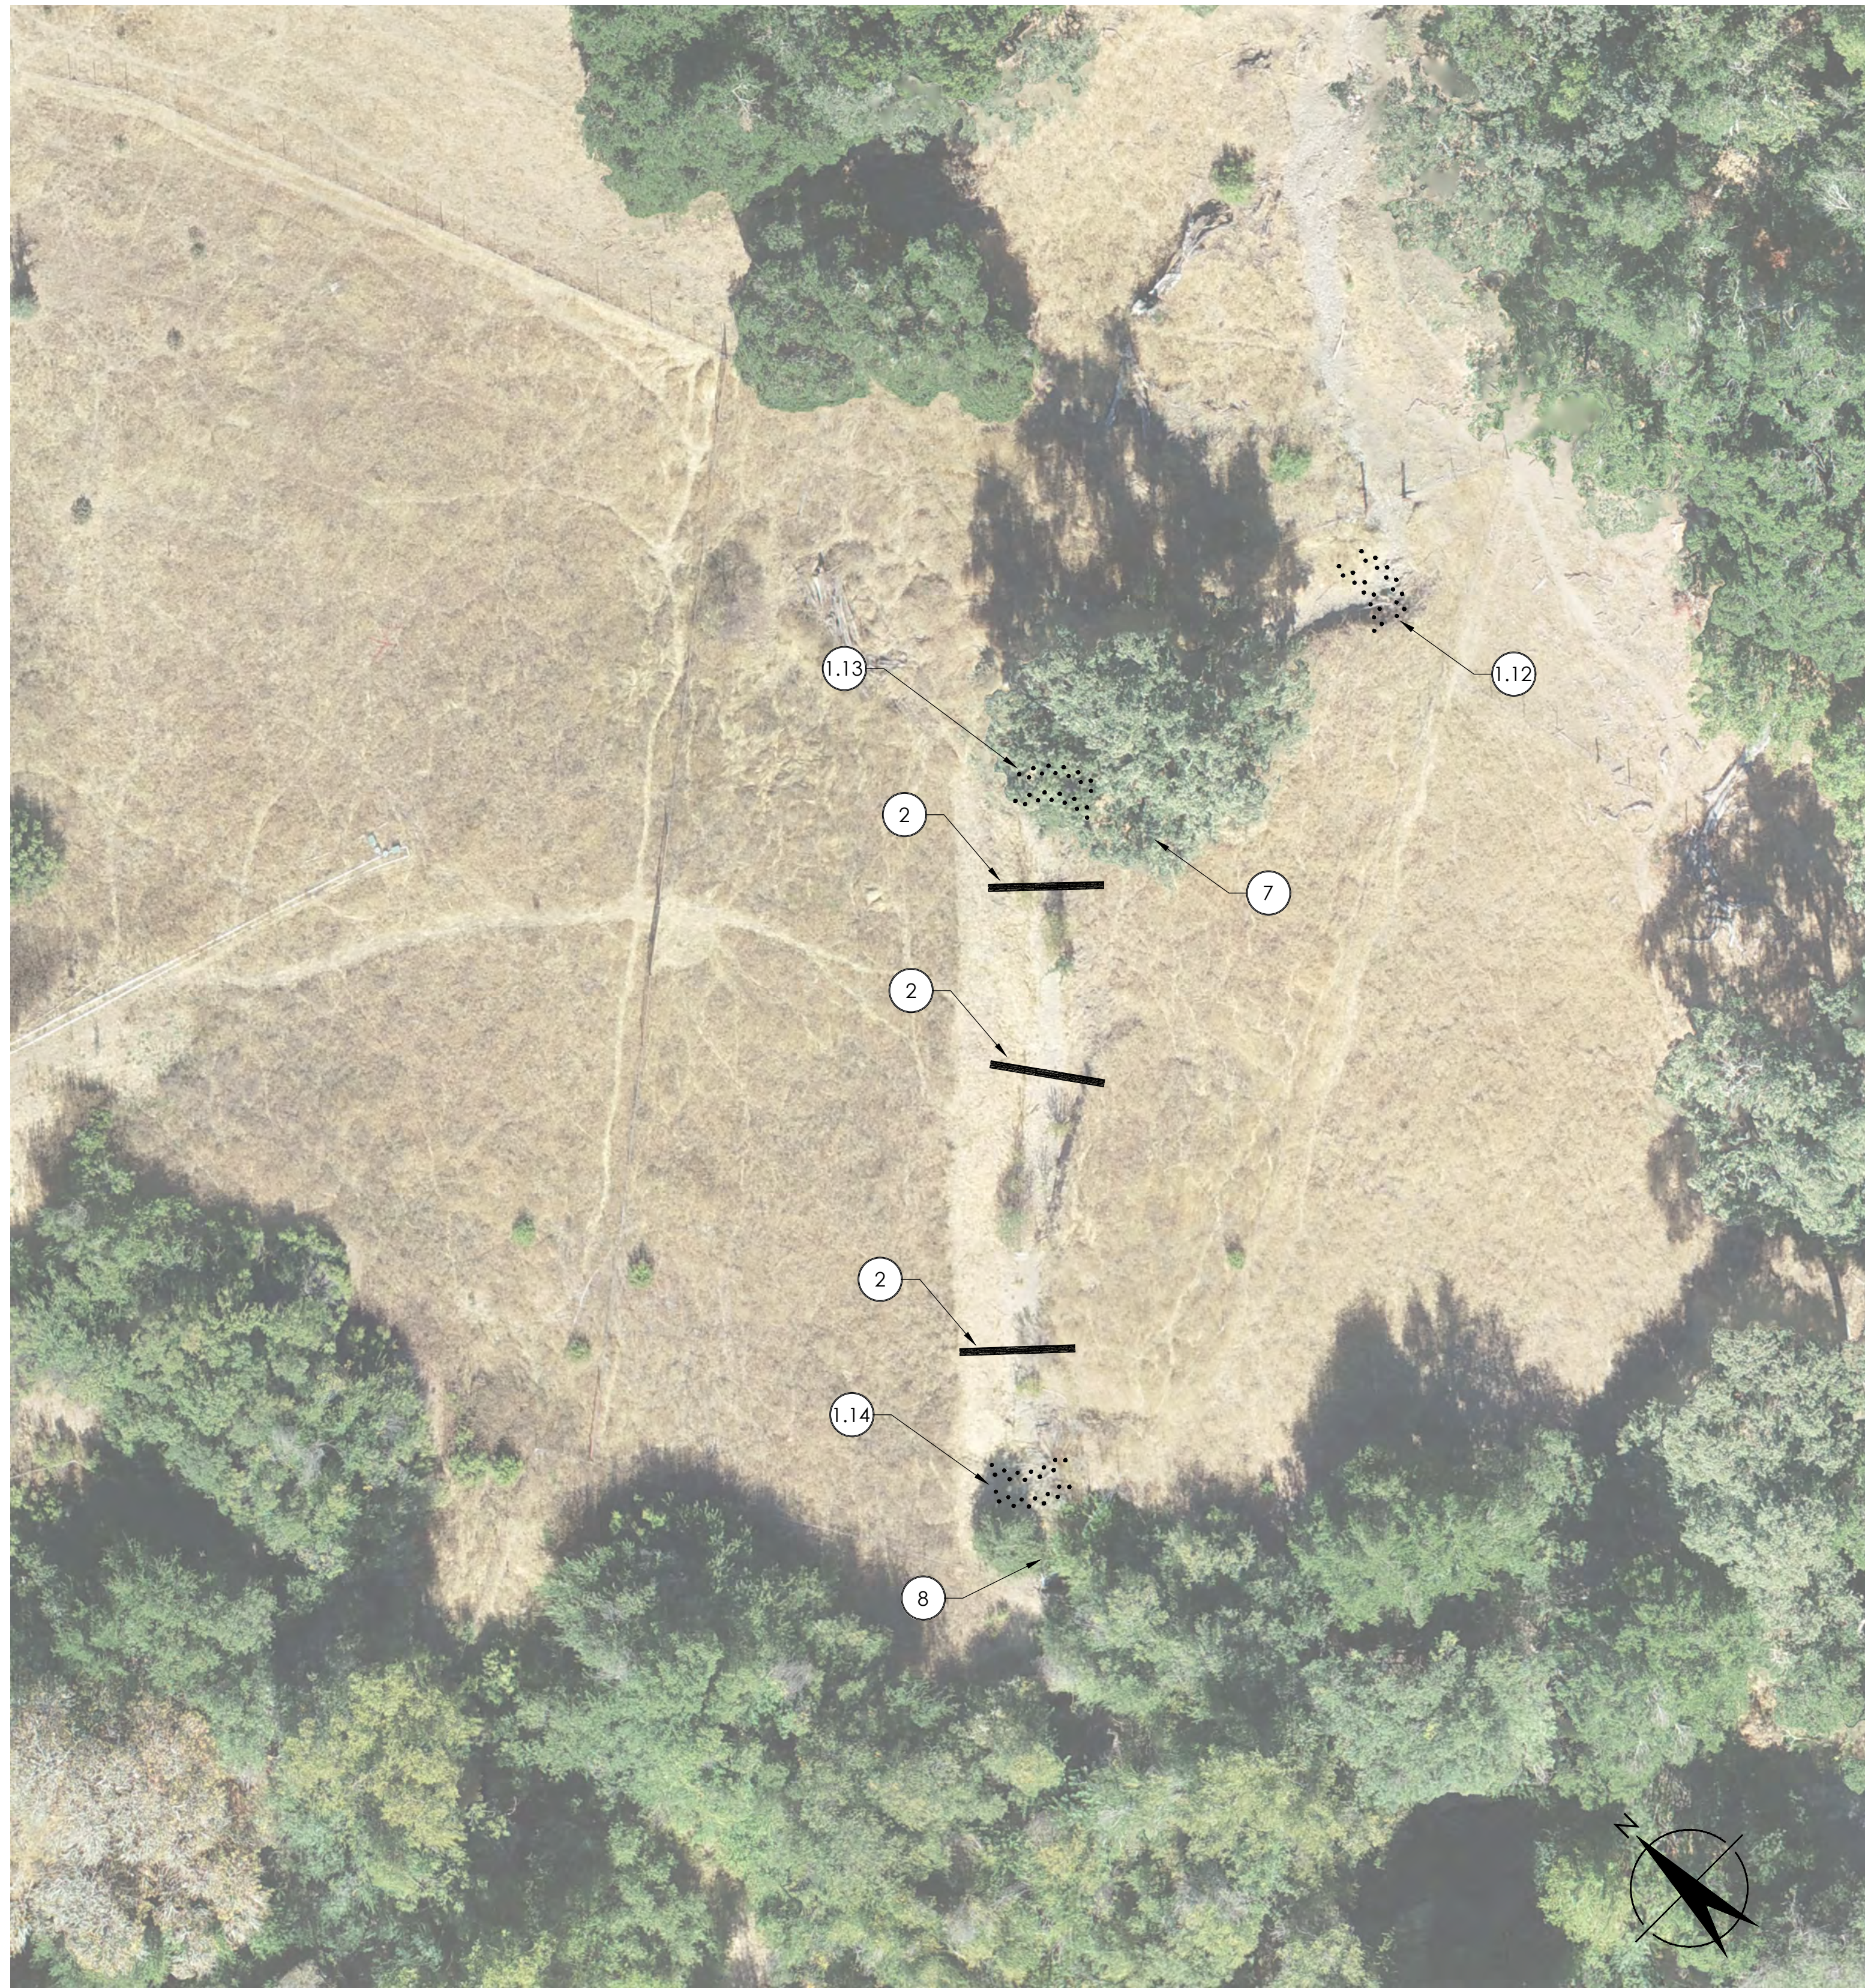
PROJECT NUMBER	222108
SCALE (AT 22" X 34")	AS NOTED
SHEET	2

Finally, we recommend additional hand work at minor erosion that has occurred at Jam 1 (Sheet 2, Note 7). This proposed work consists of placing slash along the banks and placing additional rock (approximately 4 tons of class II rock) immediately downstream and adjacent to the terminal structure.

We recommend installing three Type 1 debris jams within the Incised Eastern Tributary. The Type 1 debris jams will be constructed the same as they will be in Boyds creek (see above Section 1.2 for specifications and materials); however, the structures in the Incised Eastern Tributary should be built to be approximately 2.0 to 2.5 feet above the channel bed (rather than relative to the adjacent bank), and structure 1.12 should be built approximately 1 foot above the channel bed. Logs may need to be sourced from off-site. We assume that smaller woody debris will be sourced on-site and will mainly consist of Coyote Brush and other abundant vegetation. Each Type 1 debris jam will have 8 or more willow stakes planted upstream of the structure on the toe of the banks, with watering and irrigation as needed to maintain survival.

- ①.xx CONSTRUCT DEBRIS JAM TYPE 1 NO. xx (SEE DETAIL, SHEET 1 AND TABLE THIS SHEET)
- ② CONSTRUCT DEBRIS JAM TYPE 2 (SEE DETAIL, THIS SHEET)
- ⑦ SEE NOTE 7 ON SHEET 1
- ⑧ HAND WORK AT MINOR EROSION AROUND (EXISTING) TERMINAL JAM PLACE SLASH DEBRIS ALONG BANKS. PLACE ADDITIONAL ROCK IMMEDIATELY DOWNSTREAM AND ADJACENT TO TERMINAL STRUCTURE, PER DIRECTION OF ENGINEER'S REPRESENTATIVE. ESTIMATED QUANTITY: 4 TONS OF CLASS II ROCK.
