ANNUAL RESTORATION MONITORING REPORT

YEAR 7

SAN FELIPE CREEK RESTORATION PROJECT
SANTA CLARA VALLEY HABITAT AGENCY

DECEMBER 15, 2025

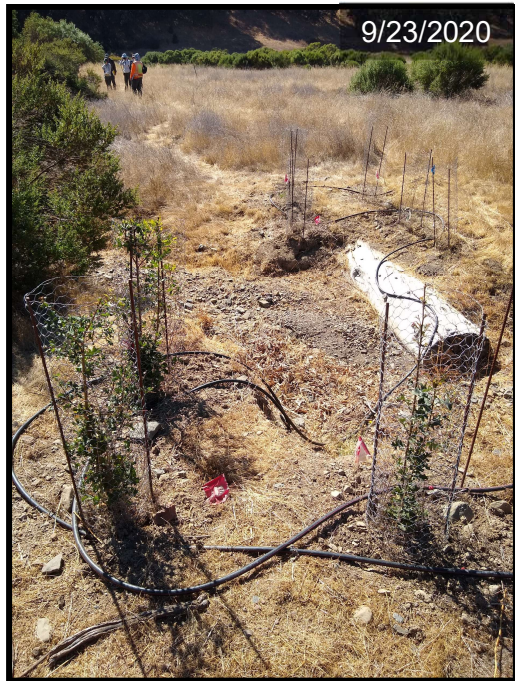
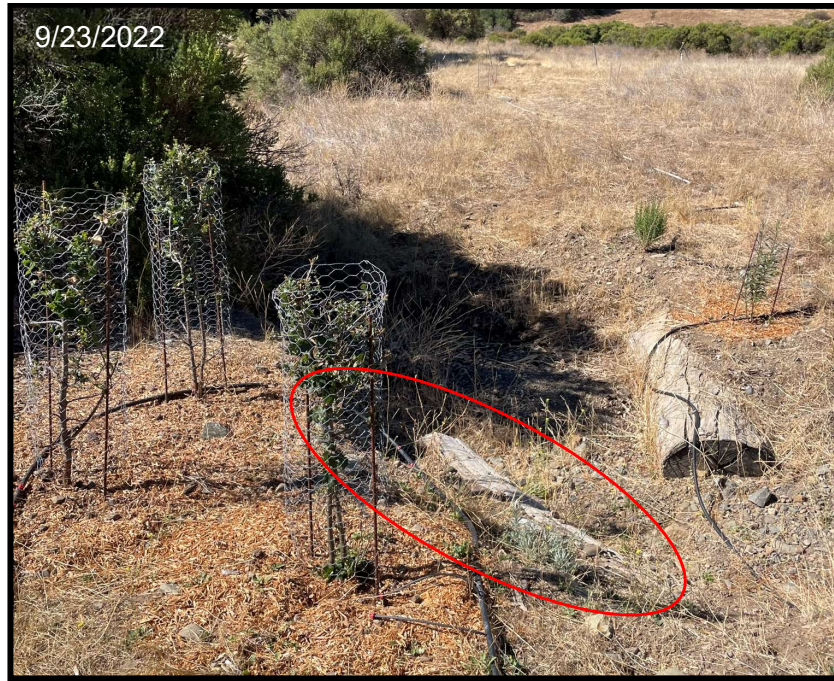
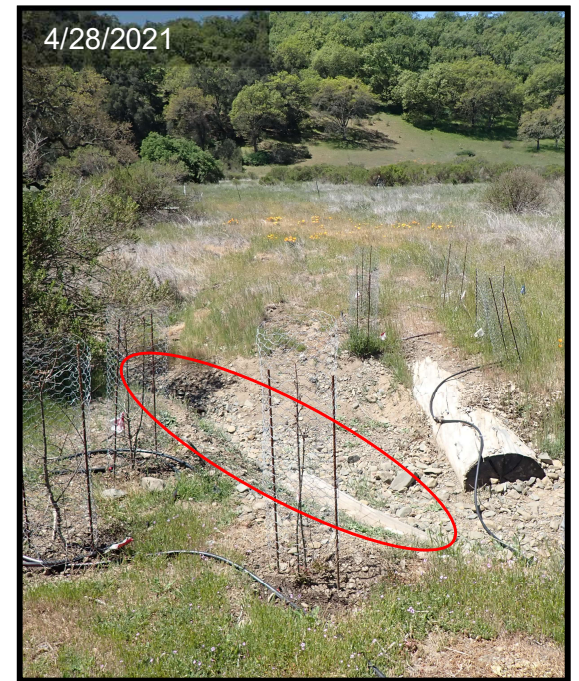
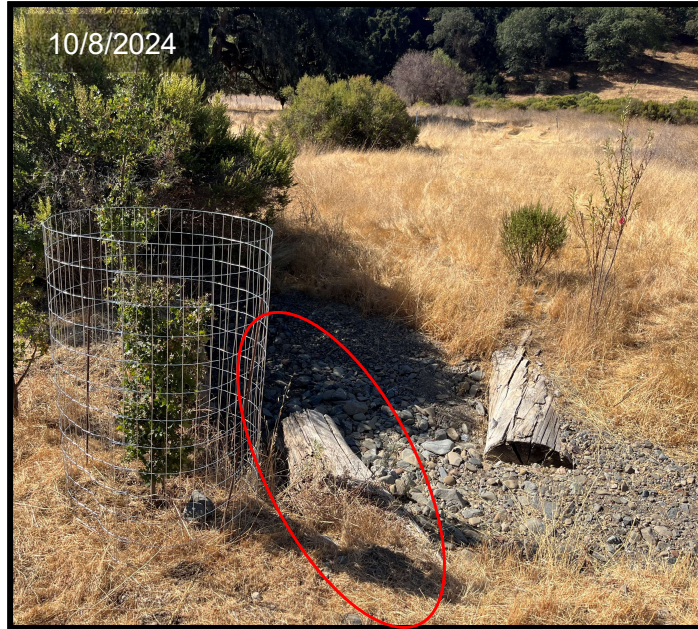
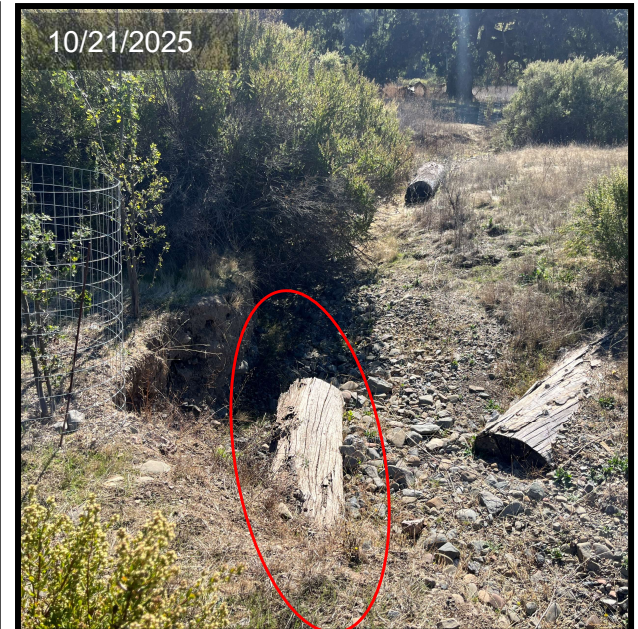
Figure 18. Comparison of San Felipe Creek at created floodplain ID03-02 between Year 1, Year 2 and post-adaptive management in Year 3, Year 4, Year 5, Year 6, and Year 7, looking downstream. San Felipe Creek Restoration Project, Joseph D. Grant Park, Santa Clara County, California.

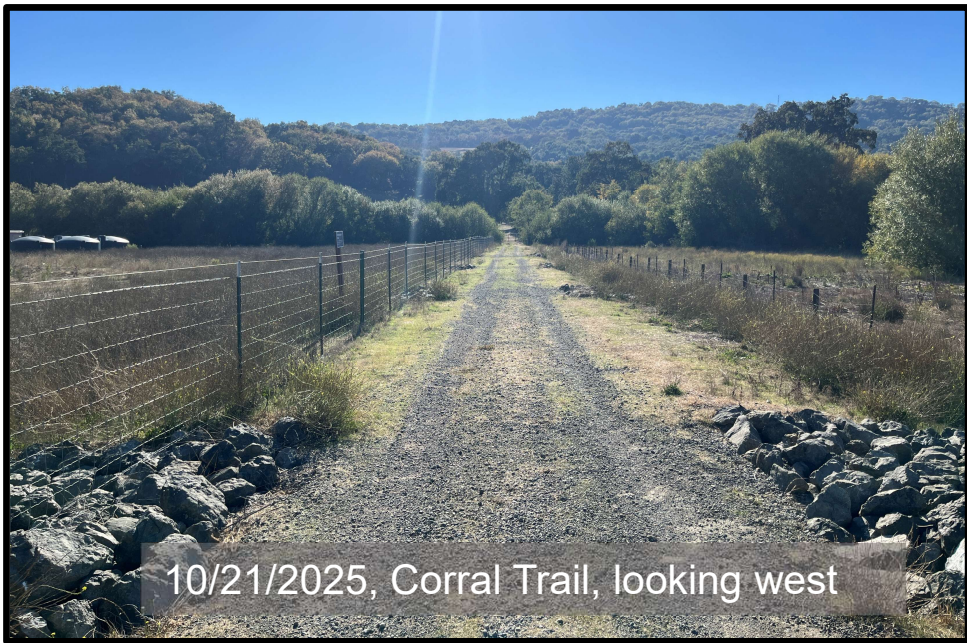
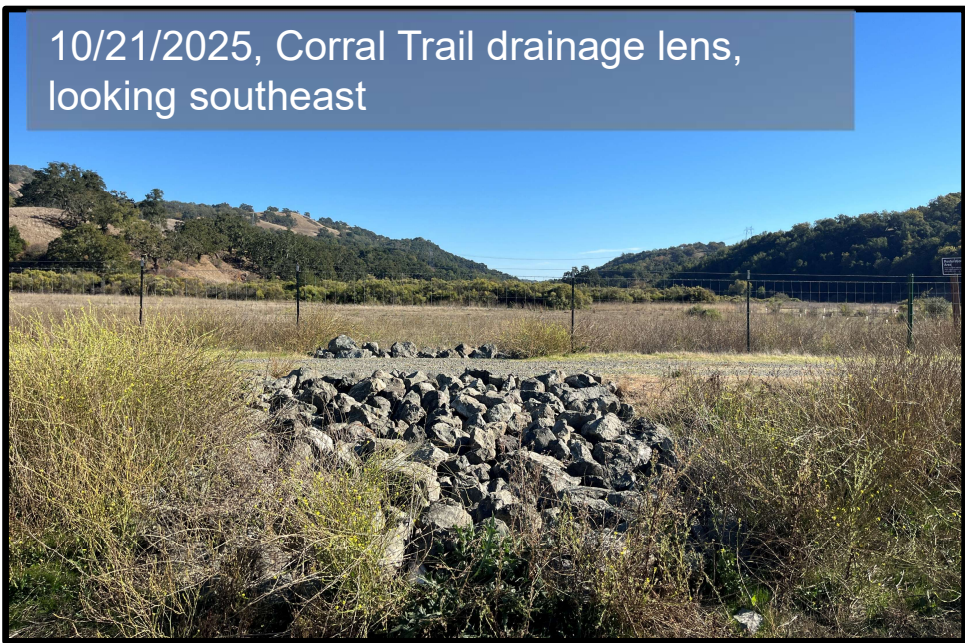
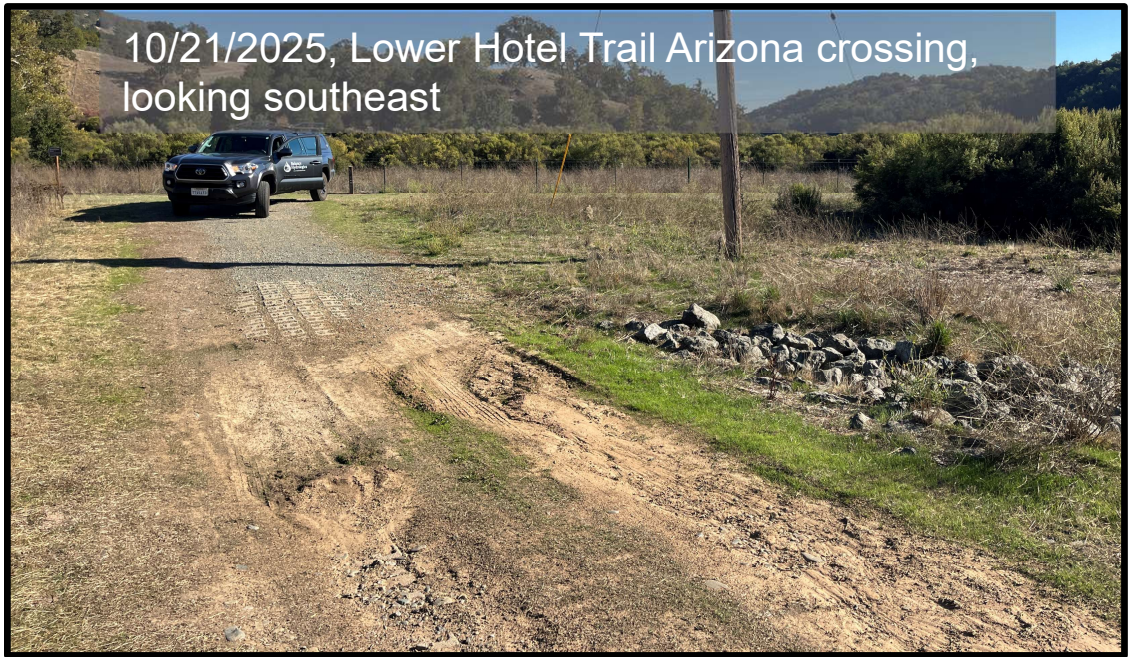
Figure 19. Corral Trail and drainage lens and Lower Hotel Trail Arizona crossing, October 21, 2025. San Felipe Creek Restoration Project, Joseph D. Grant Park, Santa Clara County, California.

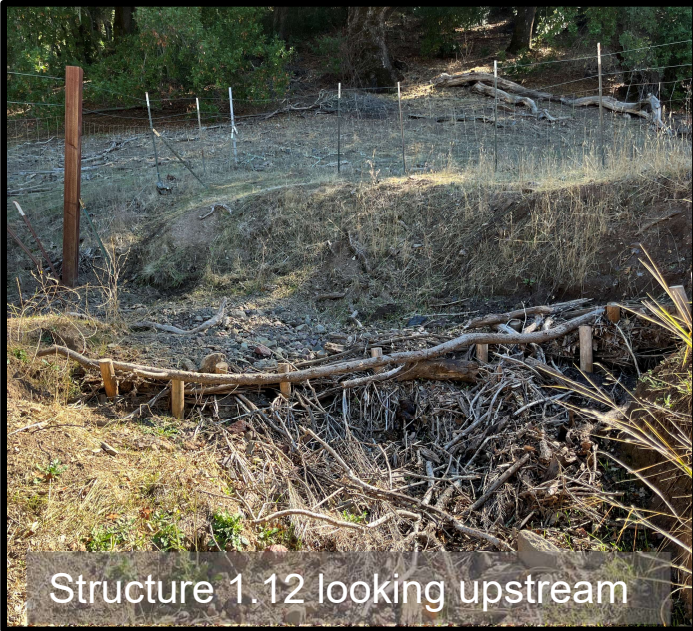
Structure 1.12 looking upstream

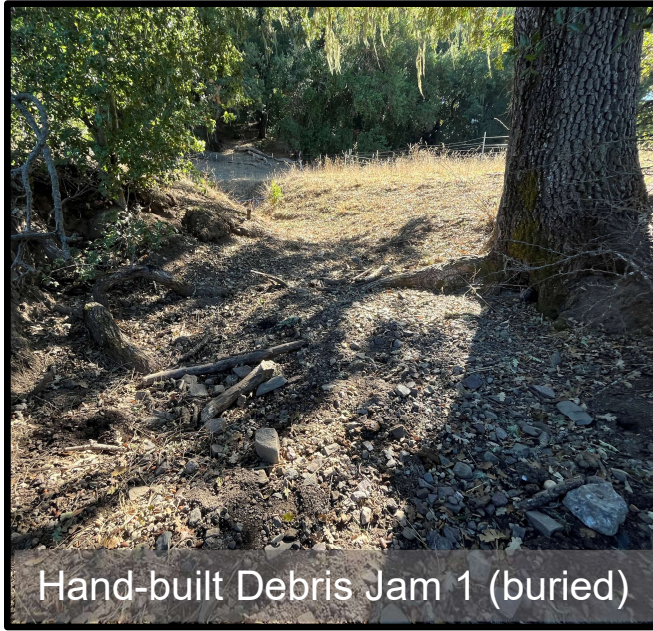
Hand-built Debris Jam 1 (buried)

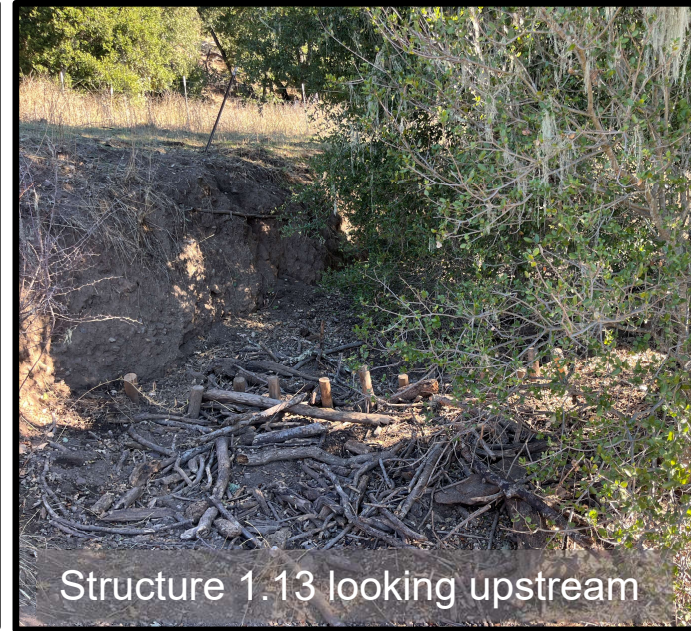
Structure 1.13 looking upstream

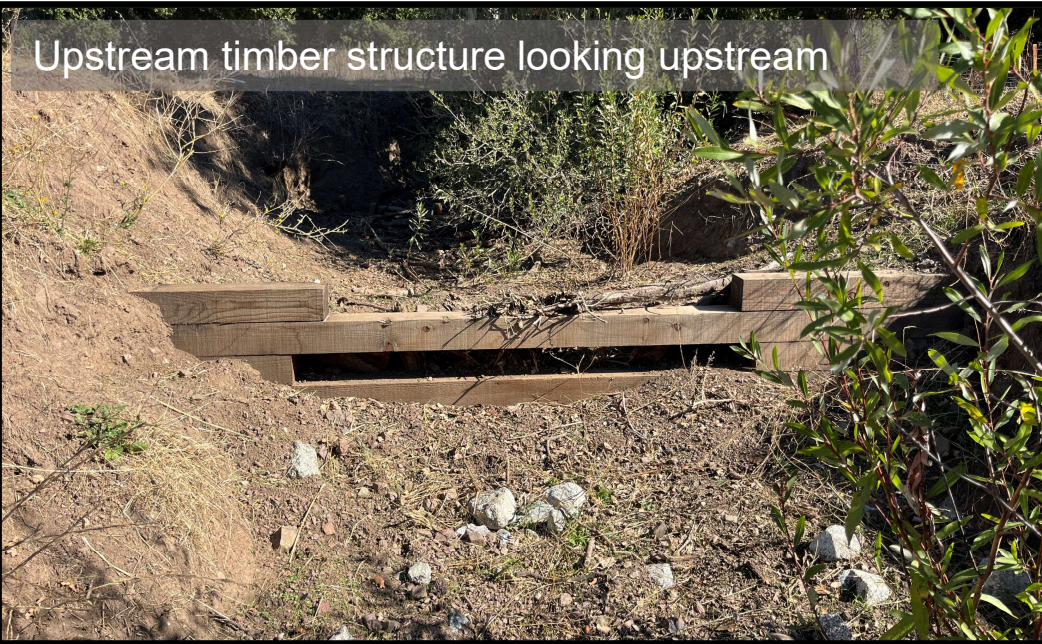
Upstream timber structure looking upstream

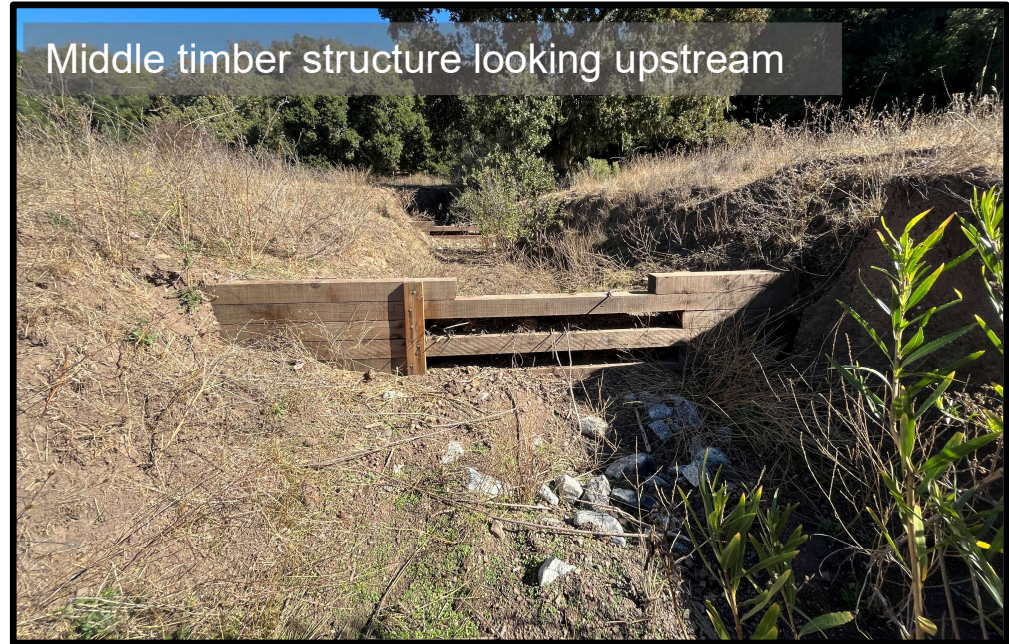
Middle timber structure looking upstream

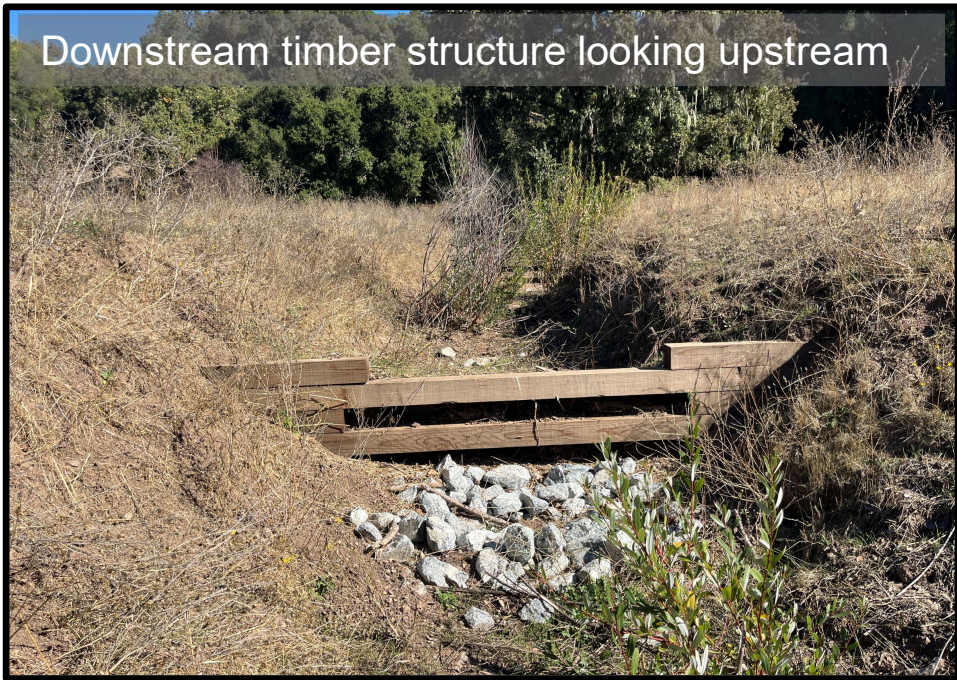
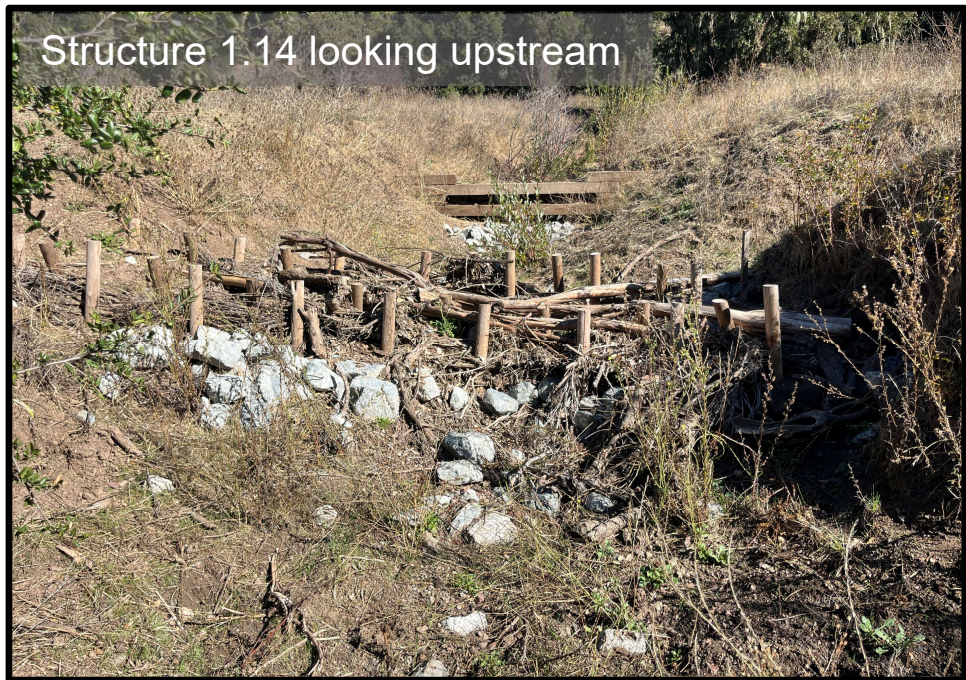
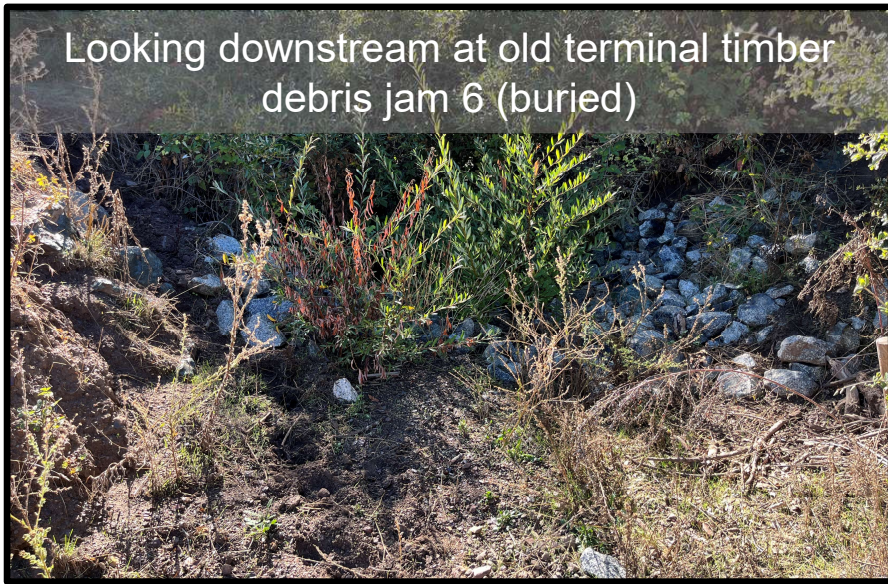
Figure 21. Debris jams at ID02-01 (continued), October 21, 2025, San Felipe Creek Restoration Project, Joseph D. Grant Park, Santa Clara County, California. All structures installed during initial construction are now buried by sediment. These photos capture the new course of staked and timber debris jams installed as part of the adaptive management work over summer 2024.
